approach

NAVAER 00-75-510

THE NAVAL AVIATION SAFETY REVIEW

MARCH 1957

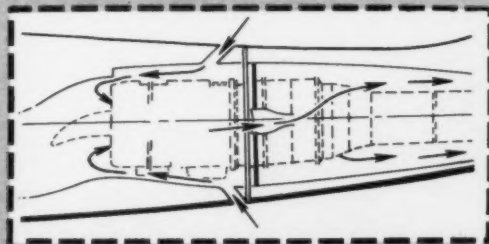
Loose objects left in the engine compartment after maintenance can be picked up by this airflow and carried into the engine.

AIRPLANE ON GROUND:
INLET DUCT AIR PRESSURE
AIR FLOW REVERSED

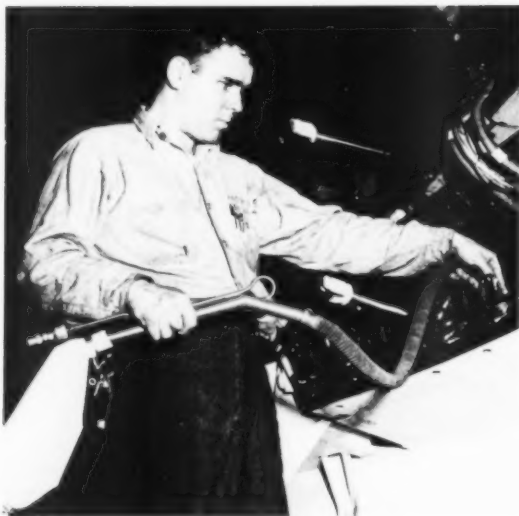
Mechanics find the homemade compressed-air-operated vacuum cleaner handy for cleanup after-service-changes.

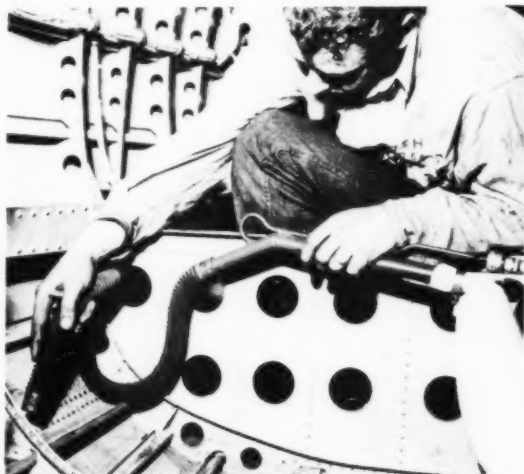
Here are specifications for manufacturing your own "Bazooka." The tool has been in use by the O & R at Norfolk since 1949.

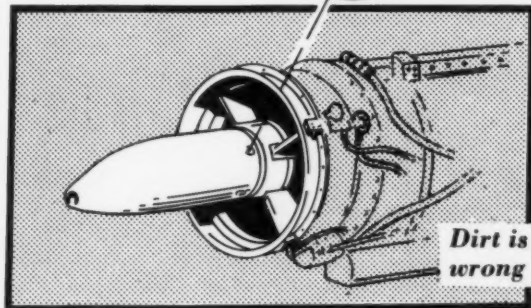
Overtorquing of starter generator cover bolt in an FJ broke the washer. It was sucked into the engine causing damage requiring engine replacement.

RETAINING BOLT (P/N 151-42006)
(TYPICAL FOUR PLACES)

WASHER
